**Flood Control Project Maintenance
Levee Inspections****LMA District Cover Sheet
Spring 2014 Levee Inspection Results****Levee District No. 0001 (Glenn County)**

Levee Inspection Report By Mile - Spring 2014

Waterway	Bank	Unit Miles	Inspection Start/End	Inspector
Unit No. 01 Sacramento River	Right	12.45	03/18/2014 03/18/2014	Bob Duffey

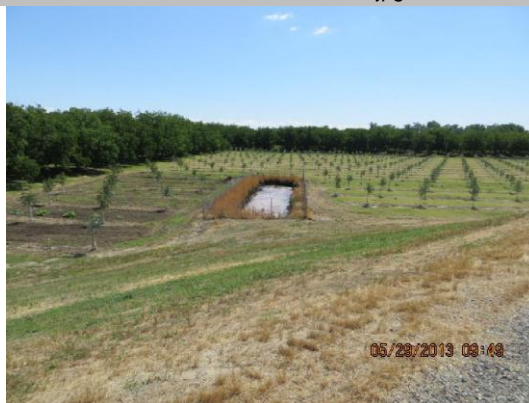
Photo 1 of 1 : UCIP_977.jpg

LM Start	0.79	Rating **	M	Issue No.	12
LM End	0.79	Issue Type +	En	Location *	LS
Category	Supplemental			GPS Latitude/Longitude	
				Start	End
Item	DWR UCIP Field Study			39.487806 °	39.487806 °
				-122.019413 °	-122.019413 °
DWR ID	DWR_LD0001G_01_s_2014_12				
Action/Comments					
Inspector Comments: FS_ID:14324					
EP_NO: 11782					
Repair Type:					
Crossing Status:					
UCIP Comments: Siphon breaker missing from WS shoulder.					
FIELD_STRUCT_DESC: 3-inch pipe through levee 2.0 feet below crown. Hose bib style sipnon breaker on WS shoulder. Pipe runs from concrete sump next to barn on LS to cesspool off WS toe (Permit No. 11782, 1977).					
FS Date: 5/29/2013

Cesspool off WS toe

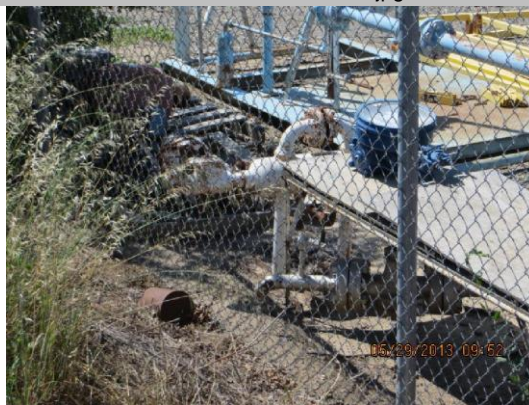
Photo 1 of 1 : UCIP_979.jpg

LM Start	0.83	Rating **	M	Issue No.	15
LM End	0.83	Issue Type +	En	Location *	LS
Category	Supplemental			GPS Latitude/Longitude	
				Start	End
Item	DWR UCIP Field Study			39.488160 °	39.488160 °
				-122.019888 °	-122.019888 °
DWR ID	DWR_LD0001G_01_s_2014_15				
Action/Comments					
Inspector Comments: FS_ID:14325					
EP_NO: 1837					
Repair Type:					
Crossing Status:					
UCIP Comments: Gasline appears abandoned, need to verify abandonment or mark actual pipe location.					
FIELD_STRUCT_DESC: 3-inch gas line through the levee 2.0 feet below the crown (Permit No. 1837, 1959). Fenced in pumping plant area next to levee with appurtenances.					
FS Date: 5/29/2013

Possible pipe at crossing, LS toe.

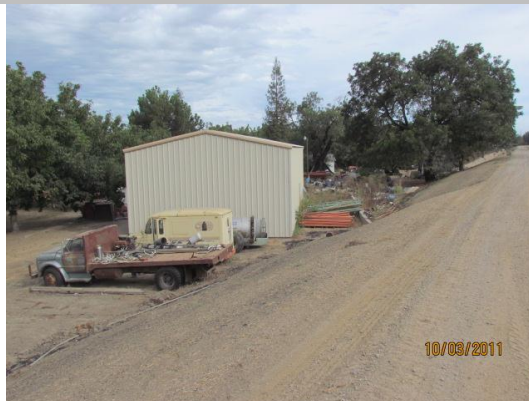
Photo 1 of 1 : rduffey_s_20140304_206.jpg

LM Start	1.10	Rating **	M	Issue No.	4
LM End	1.33	Issue Type +	En	Location *	LS
Category	Earthen Levee			GPS Latitude/Longitude	
				Start	End
Item	Encroachments			39.491887 °	39.494572 °
				-122.020238 °	-122.017840 °
DWR ID	DWR_LD0001G_01_s_2012_4				
Action/Comments					
Building

View of vehicles & equipment along the L/S toe.

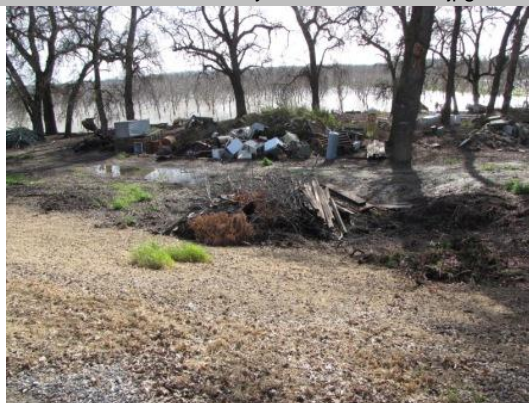
Photo 1 of 1 : rduffey_s_20140304_205.jpg

LM Start	1.23	Rating **	M	Issue No.	1
LM End	1.23	Issue Type +	Ma	Location *	WS
Category	Earthen Levee			GPS Latitude/Longitude	
				Start	End
Item	Encroachments			39.493423 °	39.493423 °
				-122.018885 °	-122.018885 °
DWR ID	DWR_LD0001G_01_s_2012_1				
Action/Comments					
Debris

View of the debris & garbage along the W/S toe.

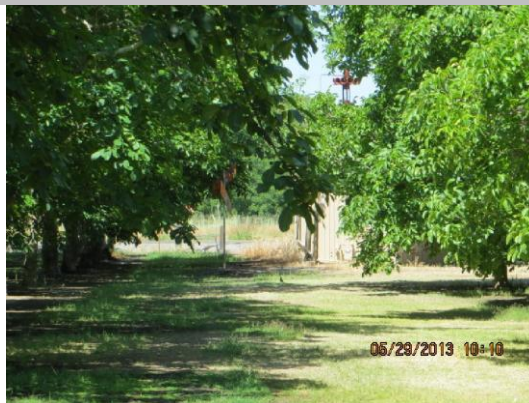
Photo 1 of 1 : UCIP_981.jpg

LM Start	1.28	Rating **	M	Issue No.	18
LM End	1.28	Issue Type +	En	Location *	WS
Category	Supplemental			GPS Latitude/Longitude	
				Start	End
Item	DWR UCIP Field Study			39.493977 °	39.493977 °
				-122.018380 °	-122.018380 °
DWR ID	DWR_LD0001G_01_s_2014_18				
Action/Comments					
Inspector Comments: FS_ID:14327 EP_NO: 2171 Repair Type: Crossing Status: UCIP Comments: Appears abandoned as well off LS toe has been removed. Need to remove from levee or mark as appropriate. FIELD_STRUCT_DESC: 2 of 2: 3-inch pipe through levee 2.0 feet below crown (Permit No. 2171, 1958). Abandoned gas-pump station 260-feet off LS toe. FS Date: 5/29/2013

Gasline markers near where removed pumping plant was located.

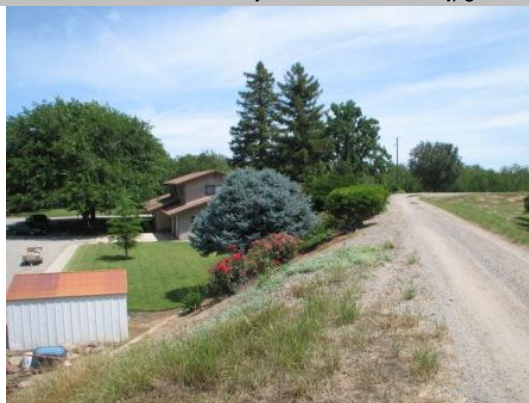
Photo 1 of 1 : rduffey_s_20140304_207.jpg

LM Start	1.35	Rating **	M	Issue No.	6
LM End	1.39	Issue Type +	En	Location *	LS
Category	Earthen Levee			GPS Latitude/Longitude	
				Start	End
Item	Vegetation			39.494828 °	39.495330 °
				-122.017632 °	-122.017163 °
DWR ID	DWR_LD0001G_01_s_2012_6				
Action/Comments					
Landscaping

View of the permitted landscape on the landside slope of the levee.

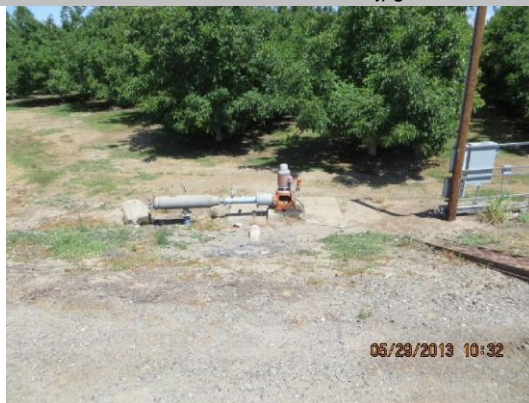
Photo 1 of 1 : UCIP_983.jpg

LM Start	2.26	Rating **	M	Issue No.	21
LM End	2.26	Issue Type +	En	Location *	LS
Category	Supplemental			GPS Latitude/Longitude	
				Start	End
Item	DWR UCIP Field Study			39.501690 °	39.501690 °
				-122.006100 °	-122.006100 °
DWR ID	DWR_LD0001G_01_s_2014_21				
Action/Comments					
Inspector Comments: FS_ID:14331					
EP_NO: 5717A					
Repair Type:					
Crossing Status:					
UCIP Comments: Pipe abandoned and should be done so properly.					
FIELD_STRUCT_DESC: 8-inch pipe sleeved through 12-inch though the levee 5-feet below the crown. Pump on landward side. Meter pole at landward toe, guy wire anchor in landward slope (Permit No. 5717A, 1969).					
FS Date: 5/29/2013

Pump at LS toe with no connection to 8-inch pipe.

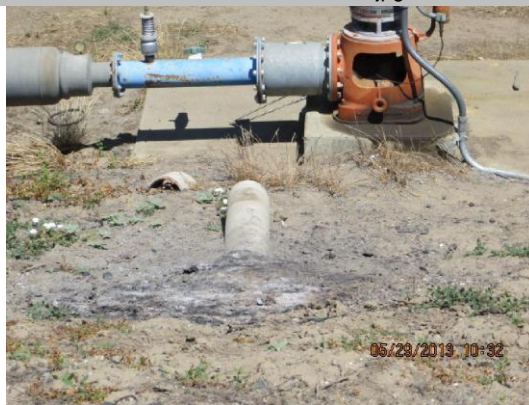
Photo 1 of 1 : UCIP_985.jpg

LM Start	2.26	Rating **	M	Issue No.	22
LM End	2.26	Issue Type +	En	Location *	LS
Category	Supplemental			GPS Latitude/Longitude	
				Start	End
Item	DWR UCIP Field Study			39.501690 °	39.501690 °
				-122.006099 °	-122.006099 °
DWR ID	DWR_LD0001G_01_s_2014_22				
Action/Comments					
Inspector Comments: FS_ID:14332					
EP_NO: N/A					
Repair Type:					
Crossing Status:					
UCIP Comments: Appears abandoned and should be done so properly.					
FIELD_STRUCT_DESC: 12-inch pipe through levee 5-feet below crown. Flap gate on W.S. 8-inch pipe sleeved through 12-inch. Open on LS. Originally included in the 1960 O&M manual.					
FS Date: 5/29/2013

Pipe next to pump at LS toe.

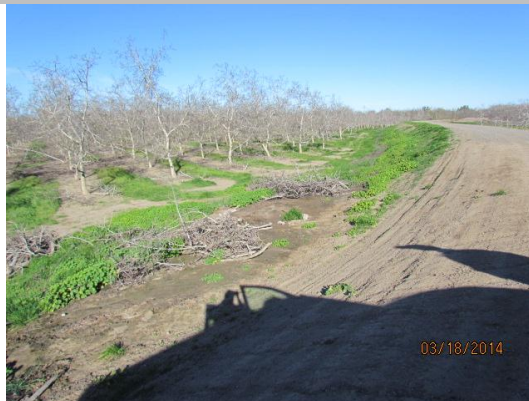
Photo 1 of 1 : rduffey_s_20140407_152.jpg

LM Start	3.08	Rating **	M	Issue No.	45
LM End	3.08	Issue Type +	En	Location *	LS
Category	Earthen Levee			GPS Latitude/Longitude	
				Start	End
Item	Encroachments			39.512914 °	39.512914 °
				-122.009063 °	-122.009063 °
DWR ID	DWR_LD0001G_01_s_2014_45				
Action/Comments					
Prunings

View of the removed prunings from the l/s slope.

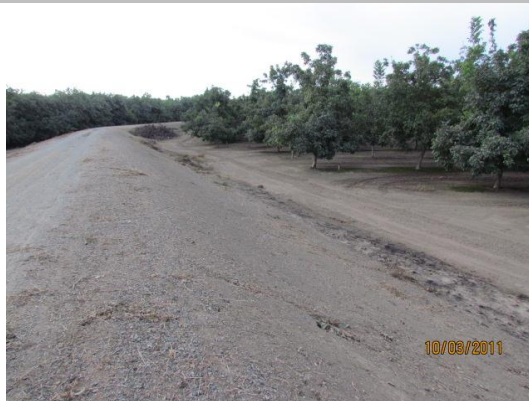
Photo 1 of 1 : rduffey_s_20140304_215.jpg

LM Start	3.13	Rating **	A/W	Issue No.	26
LM End	3.13	Issue Type +	Ma	Location *	WS
Category	Earthen Levee			GPS Latitude/Longitude	
				Start	End
Item	Animal Control			39.513358 °	39.513358 °
				-122.009448 °	-122.009448 °
DWR ID	DWR_LD0001G_01_s_2012_26				
Action/Comments					
No rodents visible, but rodent burrows visible; need to backfill and compact or grout burrows.

View of repaired rodent holes along the W/S slope.

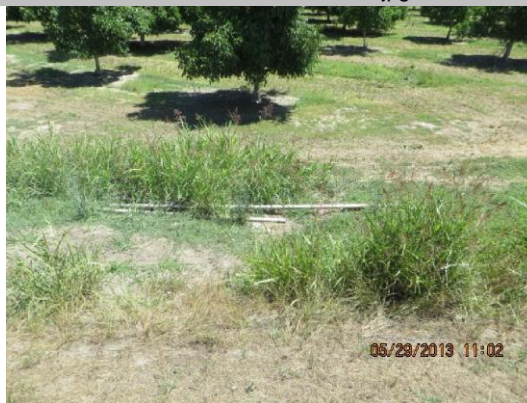
Photo 1 of 1 : UCIP_1427.jpg

LM Start	3.18	Rating **	M	Issue No.	24
LM End	3.18	Issue Type +	En	Location *	WS
Category	Supplemental			GPS Latitude/Longitude	
				Start	End
Item	DWR UCIP Field Study			39.513835 °	39.513835 °
				-122.010029 °	-122.010029 °
DWR ID	DWR_LD0001G_01_s_2014_24				
Action/Comments					
Inspector Comments: FS_ID:16223					
EP_NO: 9575					
Repair Type:					
Crossing Status:					
UCIP Comments: Appears to have been abandoned. Need to verify pipe was grouted/abandoned properly.					
FIELD_STRUCT_DESC: 12-inch pipe through levee 14.0 feet below crown. Flap Gate on waterward end (ABO No. 9575, 1974).					
FS Date: 5/29/2013

Flap gate visible at WS toe.

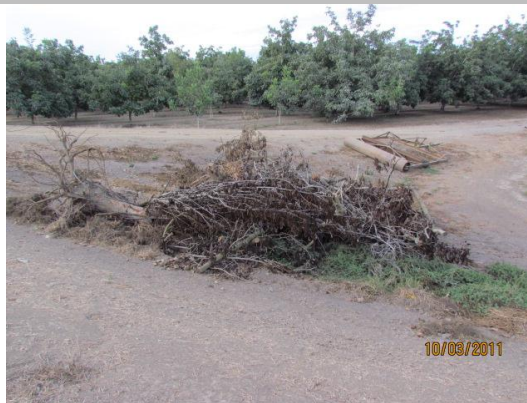
Photo 1 of 1 : rduffey_s_20140304_213.jpg

LM Start	3.22	Rating **	M	Issue No.	16
LM End	3.22	Issue Type +	Ma	Location *	LS
Category	Earthen Levee			GPS Latitude/Longitude	
				Start	End
Item	Encroachments			39.514378 °	39.514378 °
				-122.010306 °	-122.010306 °
DWR ID	DWR_LD0001G_01_s_2012_16				
Action/Comments					
Prunings

View of the prunings pile along the L/S toe.

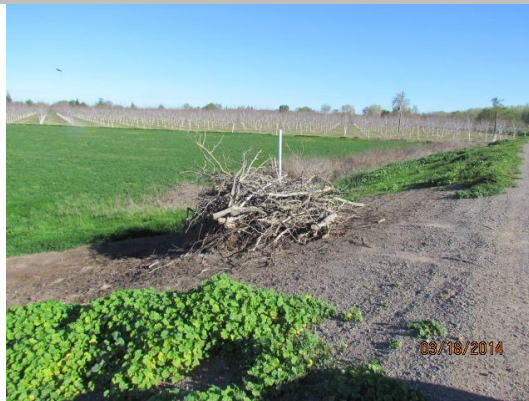
Photo 1 of 1 : rduffey_s_20140407_153.jpg

View of the prunings along the l/s slope.

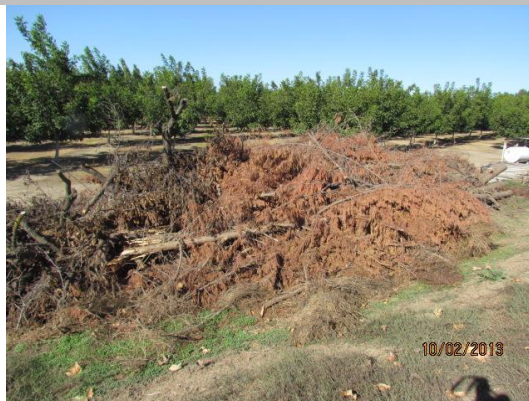
Photo 1 of 1 : rduffey_s_20140304_216.jpg

LM Start	3.69	Rating **	M	Issue No.	56
LM End	3.69	Issue Type +	En	Location *	LS
Category	Earthen Levee			GPS Latitude/Longitude	
				Start	End
Item	Encroachments			39.520623 °	39.520623 °
				-122.010457 °	-122.010457 °
DWR ID	DWR_LD0001G_01_f_2013_56				
Action/Comments					
Prunings

View of the pruning & limb along the slope of the levee.

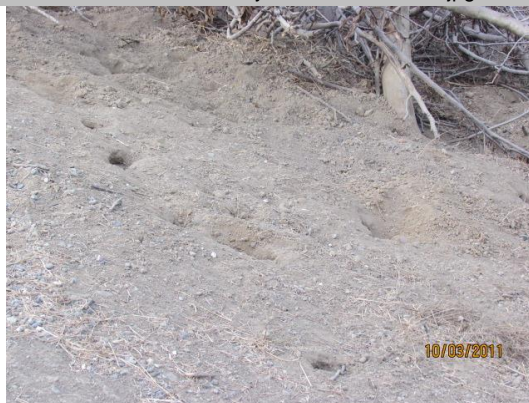
Photo 1 of 1 : rduffey_s_20140304_218.jpg

View of the rodent holes along the L/S toe.

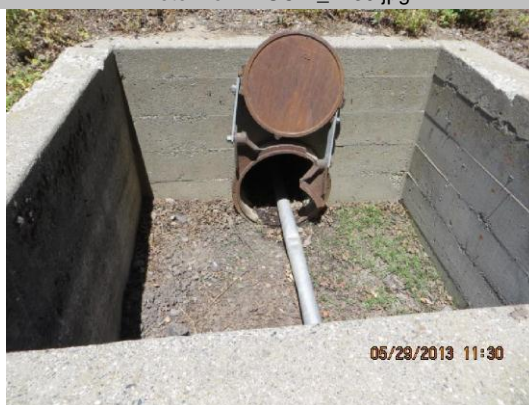
Photo 1 of 1 : UCIP_1430.jpg

LM Start	4.05	Rating **	M	Issue No.	27
LM End	4.05	Issue Type +	En	Location *	LS
Category	Supplemental			GPS Latitude/Longitude	
				Start	End
Item	DWR UCIP Field Study			39.524990 °	39.524990 °
				-122.009575 °	-122.009575 °
DWR ID	DWR_LD0001G_01_s_2014_27				
Action/Comments					
Inspector Comments: FS_ID:16243					
EP_NO: 9572					
Repair Type:					
Crossing Status:					
UCIP Comments: Broken flap gate and Concrete headwall on LS toe possibly tilting. Also a 3-inch alluminum irrigation line through the pipe.					
FIELD_STRUCT_DESC: 18-inch pipe through levee 7.3 feet below crown. Flap gate in 6'X6'concrete box on waterward end. Concrete bulkhead at landward toe (ABO No. 9572, 1974). Originally included in the 1960 O&M manual.					
FS Date: 5/29/2013

Distribution box on WS toe with broken flap gate and 3-inch aluminum irrigation pipe.

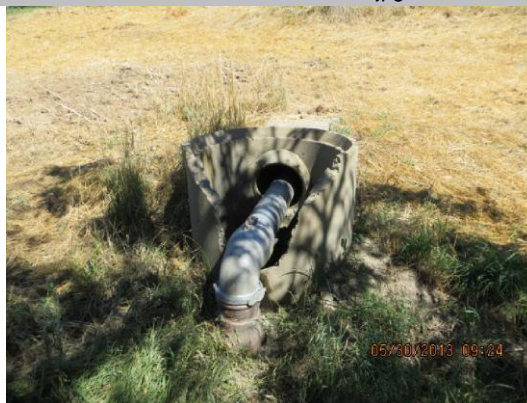
Photo 1 of 1 : UCIP_987.jpg

UCIP Comments: Gate valve broken off in concrete standpipe on WS shoulder. 8-inch aluminum pipe sleeved through pipe prevents closure of 18-inch pipe. All concrete standpipes have been modified or broken.

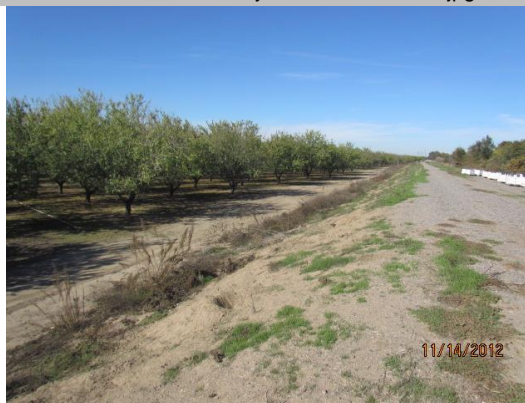
Photo 1 of 1 : rduffey_s_20140304_208.jpg

View of the rodent hole along the levee slope.

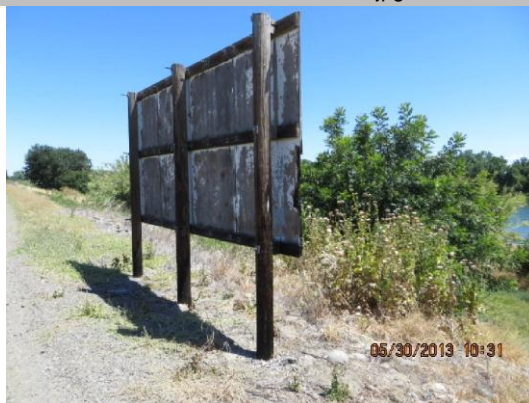
Photo 1 of 1 : UCIP_991.jpg

LM Start	6.27	Rating **	M	Issue No.	29
LM End	6.27	Issue Type +	En	Location *	LS
Category	Supplemental			GPS Latitude/Longitude	
				Start	End
Item	DWR UCIP Field Study			39.549911 °	39.549911 °
				-122.002102 °	-122.002102 °
DWR ID	DWR_LD0001G_01_s _ 2014_29				
Action/Comments					
Inspector Comments: FS_ID:14352					
EP_NO: 5118					
Repair Type:					
Crossing Status:					
UCIP Comments: New gasline markers should be installed as existing signage has been sun faded					
FIELD_STRUCT_DESC: 1 of 2: 12.75-inch high pressure gas line through levee 3.0 feet below crown (Permit No. 5118, 1965).					
FS Date: 5/30/2013

Gasline sign on WS shoulder.

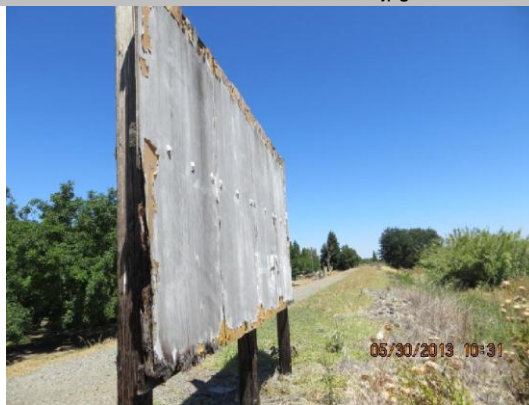
Photo 1 of 1 : UCIP_1429.jpg

LM Start	6.28	Rating **	M	Issue No.	30
LM End	6.28	Issue Type +	En	Location *	LS
Category	Supplemental			GPS Latitude/Longitude	
				Start	End
Item	DWR UCIP Field Study			39.549938 °	39.549938 °
				-122.002110 °	-122.002110 °
DWR ID	DWR_LD0001G_01_s _ 2014_30				
Action/Comments					
Inspector Comments: FS_ID:16224					
EP_NO: 5118					
Repair Type:					
Crossing Status:					
UCIP Comments: Pipe needs new gasline markers as sign on WS					
shoulder is sunbleached and cannot be read.					
FIELD_STRUCT_DESC: 2 of 2: 12.75-inch high pressure gas line					
through levee 3.0 feet below crown (Permit No. 5118, 1965). Gasline					
sign on WS shoulder.					
FS Date: 5/30/2013

Gasline sign on WS shoulder.

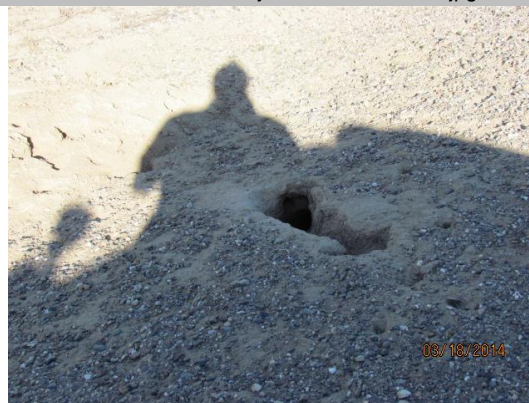
Photo 1 of 1 : rduffey_s_20140407_154.jpg

View of the rodent activity along the l/s slope.

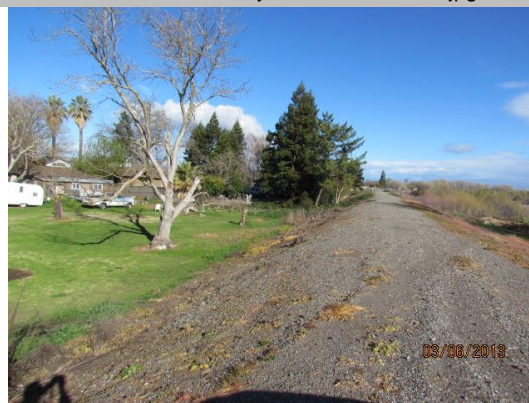
Photo 1 of 1 : rduffey_s_20140304_212.jpg

LM Start	6.36	Rating **	A/W	Issue No.	13
LM End	6.37	Issue Type +	Ma	Location *	LS
Category	Earthen Levee			GPS Latitude/Longitude	
				Start	End
Item	Encroachments			39.551068 °	39.551238 °
				-122.002450 °	-122.002498 °
DWR ID	DWR_LD0001G_01_s_2012_13				
Action/Comments					
Prunings

View of the removed prunings from the landside toe.

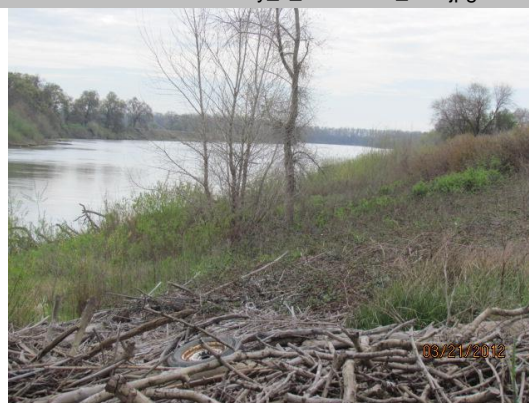
Photo 1 of 1 : rduffey_s_20140304_210.jpg

LM Start	6.50	Rating **	A/W	Issue No.	10
LM End	6.70	Issue Type +	Ma	Location *	WS
Category	Earthen Levee			GPS Latitude/Longitude	
				Start	End
Item	Vegetation			39.555274 °	39.555274 °
				-122.003505 °	-122.003505 °
DWR ID	DWR_LD0001G_01_s_2012_10				
Action/Comments					
Environmental Requirements.

View of the Army Corps of Engineers mitigation site.

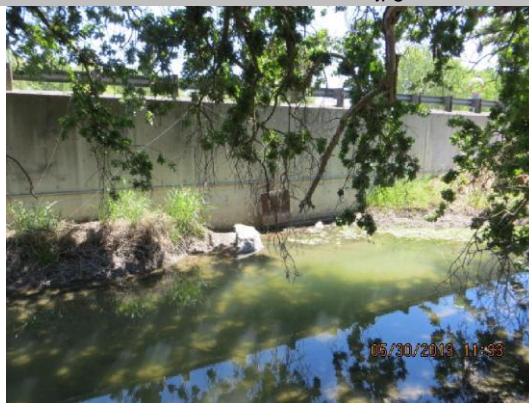
Photo 1 of 1 : UCIP_994.jpg

LM Start	6.83	Rating **	M	Issue No.	31
LM End	6.83	Issue Type +	En	Location *	WS
Category	Supplemental			GPS Latitude/Longitude	
				Start	End
Item	DWR UCIP Field Study			39.557721 °	39.557721 °
				-122.004267 °	-122.004267 °
DWR ID	DWR_LD0001G_01_s_2014_31				
Action/Comments					
Inspector Comments: FS_ID:14373					
EP_NO: 1443A					
Repair Type:					
Crossing Status:					
UCIP Comments: Pipe abandoned, but need to verify if it was abandoned properly.					
FIELD_STRUCT_DESC: 36-inch concrete encased pipe through levee 9.0 feet below crown. Steel plate welded over pipe at LS toe. 3-inch steel vent pipe on LS toe. Originally included in the 1960 O&M manual.					
FS Date: 5/30/2013

Pipe with steel plate welded over end on LS of levee crown.

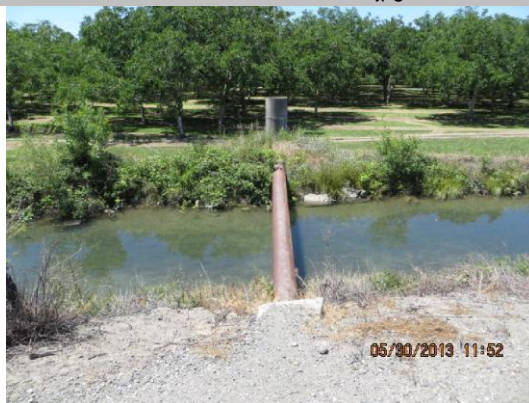
Photo 1 of 1 : UCIP_997.jpg

LM Start	7.01	Rating **	M	Issue No.	32
LM End	7.01	Issue Type +	En	Location *	WS
Category	Supplemental			GPS Latitude/Longitude	
				Start	End
Item	DWR UCIP Field Study			39.560071 °	39.560071 °
				-122.005039 °	-122.005039 °
DWR ID	DWR_LD0001G_01_s_2014_32				
Action/Comments					
Inspector Comments: FS_ID:14384					
EP_NO: 9702					
Repair Type:					
Crossing Status:					
UCIP Comments: Abandoned and should be done so properly.					
FIELD_STRUCT_DESC: 20-inch concrete encased steel pipe through levee 7.2 feet below crown. Slant pump on waterward bank. Slide gate in 36-inch concrete standpipe on waterward berm (ABO No. 9702, 1974). Originally included in the 1960 O&M manual.					
FS Date: 5/30/2013

Pipe on LS toe with concrete standpipe visible.

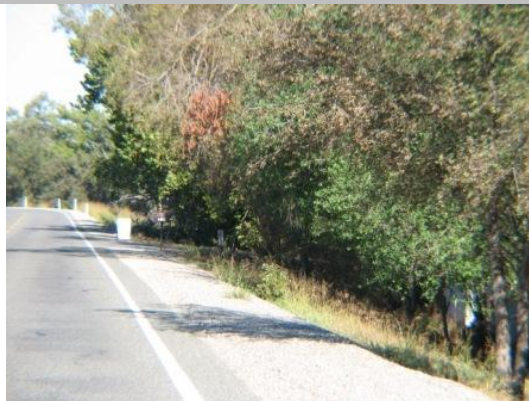
Photo 1 of 1 : rduffey_s_20140304_214.jpg

View of the trees and vegetation along the waterside slope of the levee.

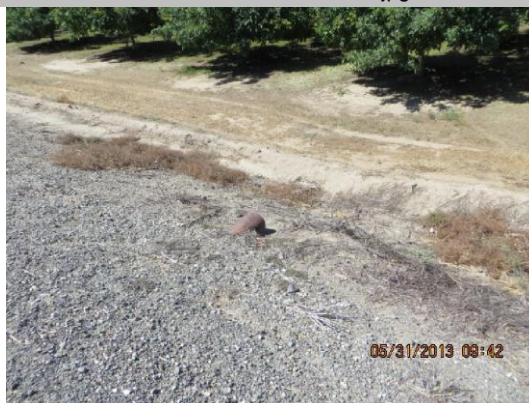
Photo 1 of 1 : UCIP_1001.jpg

LM Start	8.59	Rating **	M	Issue No.	34
LM End	8.59	Issue Type +	En	Location *	WS
Category	Supplemental			GPS Latitude/Longitude	
				Start	End
Item	DWR UCIP Field Study			39.582275 °	39.582275 °
				-122.007449 °	-122.007449 °
DWR ID	DWR_LD0001G_01_s_2014_34				
Action/Comments					
Inspector Comments: FS_ID:14385					
EP_NO: 9563					
Repair Type:					
Crossing Status:					
UCIP Comments: Pipe open on both ends and damaged on WS slope.					
Pipe should be abandoned properly if appropriate.					
FIELD_STRUCT_DESC: *Abandoned* 12-inch pipe through levee 5.0					
feet below crown. Pipe open on both ends. One corrugated metal					
cutoff wall (ABO No. 9563, 1974). Originally included in the 1960 O&M					
manual.					
FS Date: 5/31/2013

Pipe on LS slope.

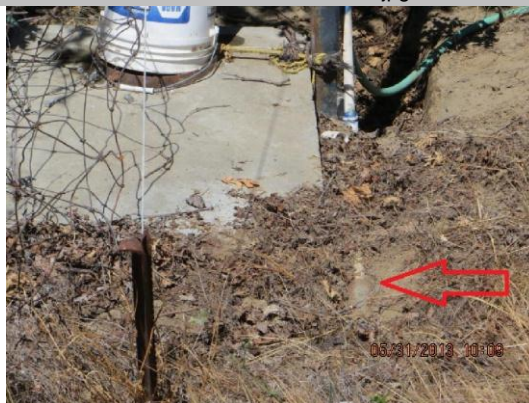
Photo 1 of 1 : UCIP_1421.jpg

LM Start	8.96	Rating **	M	Issue No.	35
LM End	8.96	Issue Type +	En	Location *	WS
Category	Supplemental			GPS Latitude/Longitude	
				Start	End
Item	DWR UCIP Field Study			39.587028 °	39.587028 °
				-122.005609 °	-122.005609 °
DWR ID	DWR_LD0001G_01_s_2014_35				
Action/Comments					
Inspector Comments: FS_ID:16204					
EP_NO: N/A					
Repair Type:					
Crossing Status:					
UCIP Comments: Need to determine if this passes completely through levee and what Permit No. was issued for it.					
FIELD_STRUCT_DESC: 1.5-inch galvanized iron pipe through the levee 6-feet below the crown. 1-inch PVC irrigation line sleeved through this conduit.					
FS Date: 5/31/2013

Pipe visible next to well with bucket over standpipe.

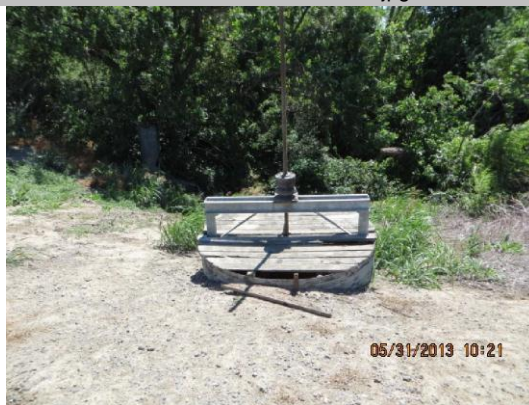
Photo 1 of 1 : UCIP_1004.jpg

LM Start	9.63	Rating **	M	Issue No.	36
LM End	9.63	Issue Type +	En	Location *	WS
Category	Supplemental			GPS Latitude/Longitude	
				Start	End
Item	DWR UCIP Field Study			39.596012 °	39.596012 °
				-122.002638 °	-122.002638 °
DWR ID	DWR_LD0001G_01_s_2014_36				
Action/Comments					
Inspector Comments: FS_ID:14389					
EP_NO: 9560					
Repair Type:					
Crossing Status:					
UCIP Comments: Heavy rust along springline of pipe. Pipe has slight deformation at centerline of levee, not noticable on crown.					
FIELD_STRUCT_DESC: 72-inch corrugated metal pipe through levee 15.0 feet below crown. Flap Gate on waterward end. Slide gate in 8' diameter corrugated metal pipe riser on waterward slope. Concrete headwalls on both ends. Two corrugated metal cutoff walls (ABO No. 9560, 1974). Originally included in the 1960 O&M manual.					
FS Date: 5/31/2013

Slide gate in 8-foot diameter CMP riser on WS slope.

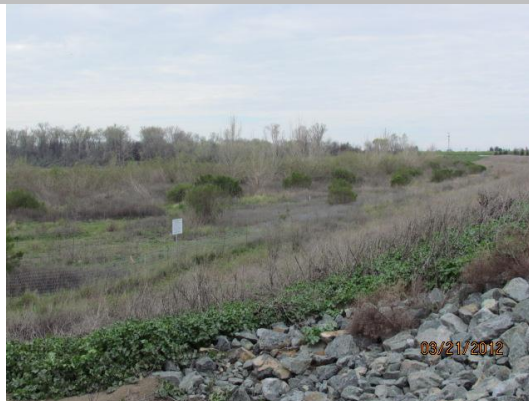
Photo 1 of 1 : rduffey_s_20140304_209.jpg

View of the Army Corps of Engineers mitigation site.

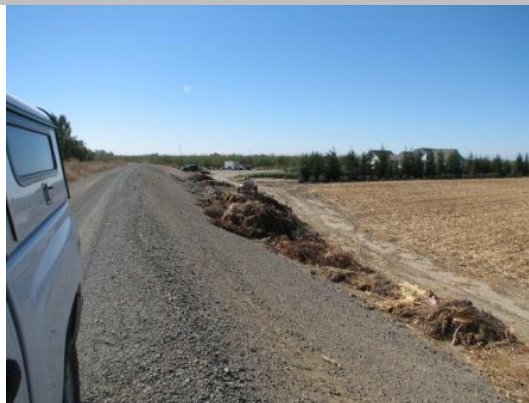
Photo 1 of 1 : rduffey_s_20140304_211.jpg

LM Start	9.70	Rating **	M	Issue No.	11
LM End	9.70	Issue Type +	Ma	Location *	LS
Category	Earthen Levee			GPS Latitude/Longitude	
				Start	End
Item	Encroachments			39.597078 °	39.597078 °
				-122.002127 °	-122.002127 °
DWR ID	DWR_LD0001G_01_s_2012_11				
Action/Comments					
Debris

View of debris along the toe of the levee.

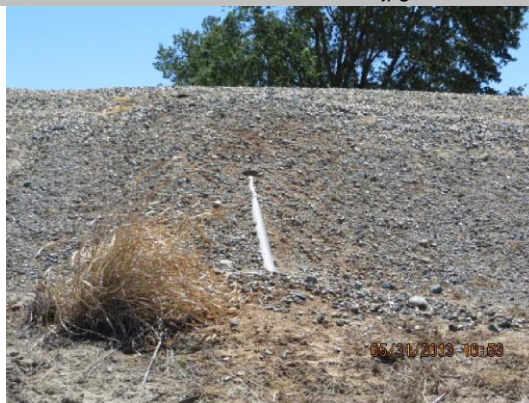
Photo 1 of 1 : UCIP_1424.jpg

LM Start	10.33	Rating **	M	Issue No.	37
LM End	10.33	Issue Type +	En	Location *	LS
Category	Supplemental			GPS Latitude/Longitude	
				Start	End
Item	DWR UCIP Field Study			39.604696 °	39.604696 °
				-121.996265 °	-121.996265 °
DWR ID	DWR_LD0001G_01_s_2014_37				
Action/Comments					
Inspector Comments: FS_ID:16205					
EP_NO: N/A					
Repair Type:					
Crossing Status:					
UCIP Comments: Need to determine Permit No. for crossing.					
FIELD_STRUCT_DESC: 6-inch steel conduit through the levee 8- inches below the crown. Pump, vent, filter, and siphon breaker on LS toe. 4-inch PVC irrigation line sleeved through conduit for vegetation rehabilitation on WS slope.					
FS Date: 5/31/2013

Pipe on LS slope.

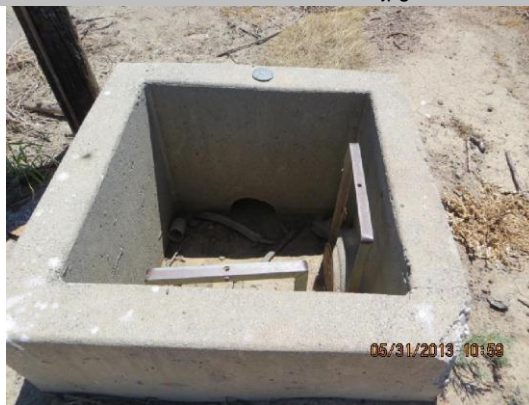
Photo 1 of 1 : UCIP_1043.jpg

LM Start	10.55	Rating **	M	Issue No.	38
LM End	10.55	Issue Type +	En	Location *	LS
Category	Supplemental			GPS Latitude/Longitude	
				Start	End
Item	DWR UCIP Field Study			39.607474 °	39.607474 °
				-121.994410 °	-121.994410 °
DWR ID	DWR_LD0001G_01_s_2014_38				
Action/Comments					
Inspector Comments: FS_ID:14561					
EP_NO: 9557					
Repair Type:					
Crossing Status:					
UCIP Comments: This pipe appears abandoned and should be done so properly.					
FIELD_STRUCT_DESC: 1 of 2: 10-inch pipe through levee 3.7 feet below crown. Pump on bank. Siphon breaker on waterward berm. One corrugated metal cutoff wall. Concrete distribution box at toe of landward slope (ABO No. 9557, 1974). Originally included in the 1960 O&M manual.					
FS Date: 5/31/2013

Concrete distribution box at LS toe with outlet from pipe through levee.

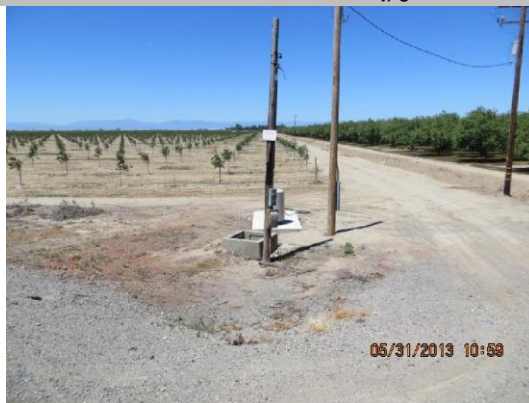
Photo 1 of 1 : UCIP_1046.jpg

LM Start	10.55	Rating **	M	Issue No.	39
LM End	10.55	Issue Type +	En	Location *	LS
Category	Supplemental			GPS Latitude/Longitude	
				Start	End
Item	DWR UCIP Field Study			39.607474 °	39.607474 °
				-121.994410 °	-121.994410 °
DWR ID	DWR_LD0001G_01_s_2014_39				
Action/Comments					
Inspector Comments: FS_ID:14562					
EP_NO: 9557					
Repair Type:					
Crossing Status:					
UCIP Comments: Abandoned and should be done so properly.					
FIELD_STRUCT_DESC: 2 of 2: 1.5 inch galvanized iron electrical					
conduit through the levee 3.0 feet below the crown (ABO No. 9557,					
1974). Originally included in the 1960 O&M manual.					
FS Date: 5/31/2013

Source at JP next to concrete distribution box at LS toe.

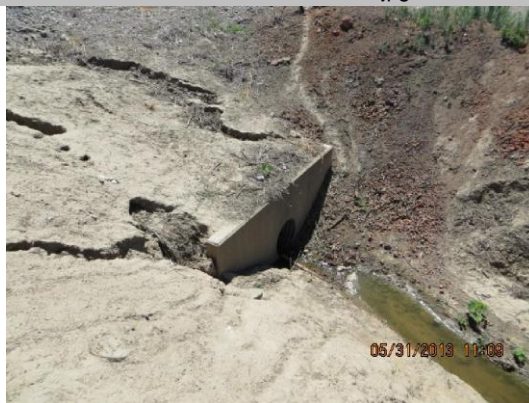
Photo 1 of 1 : UCIP_1052.jpg

LM Start	10.57	Rating **	M	Issue No.	40
LM End	10.57	Issue Type +	En	Location *	LS
Category	Supplemental			GPS Latitude/Longitude	
				Start	End
Item	DWR UCIP Field Study			39.607688 °	39.607688 °
				-121.994278 °	-121.994278 °
DWR ID	DWR_LD0001G_01_s_2014_40				
Action/Comments					
Inspector Comments: FS_ID:14564 EP_NO: 9556 Repair Type: Crossing Status: UCIP Comments: Flap gate dissabled in open position. Pipe rusted through at WS toe upstream of Flapgate. FIELD_STRUCT_DESC: 24-inch corrugated metal pipe through levee 15.0 feet below crown. Flap gate on waterward end. Slide gate in CMP riser on waterward slope. Two CM cutoff walls. Concrete headwall on landside and under outlet at WS toe (ABO No. 9556, 1974). Originally included in the 1960 O&M manual. FS Date: 5/31/2013

Concrete headwall and pipe at LS toe.

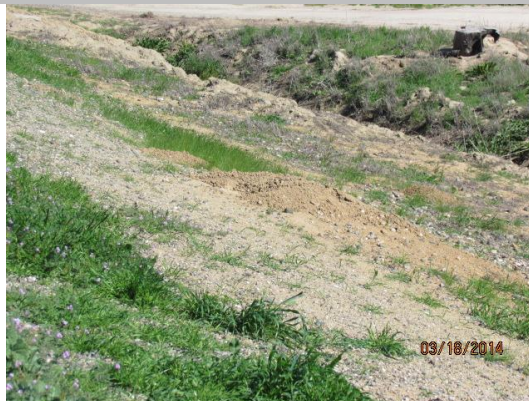
Photo 1 of 1 : rduffey_s_20140407_155.jpg

View of the rodent activity along the w/s slope.

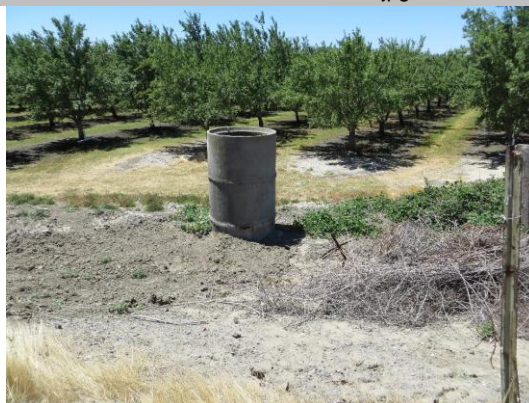
Photo 1 of 1 : UCIP_1056.jpg

LM Start	11.91	Rating **	M	Issue No.	41
LM End	11.91	Issue Type +	En	Location *	LS
Category	Supplemental			GPS Latitude/Longitude	
				Start	End
Item	DWR UCIP Field Study			39.625463 °	39.625463 °
				-122.000658 °	-122.000658 °
DWR ID	DWR_LD0001G_01_s_2014_41				
Action/Comments					
Inspector Comments: FS_ID:14567					
EP_NO: 9554					
Repair Type:					
Crossing Status:					
UCIP Comments: Erosion and sloughing on LS slope possibly due to rodent activity in area.					
FIELD_STRUCT_DESC: 24-inch corrugated metal pipe through levee 11.0 feet below crown. Slide gate in 36-inch corrugated metal pipe riser on waterward slope. 48-inch concrete standpipe on landward toe. Two corrugated metal cutoff walls (ABO No. 9554, 1974). Originally included in the 1960 O&M manual.					
FS Date: 5/31/2013

Concrete standpipe on LS toe.

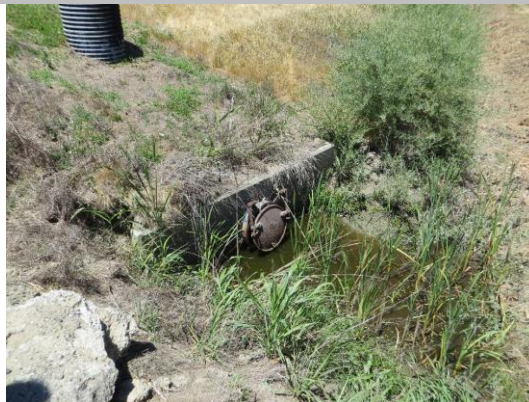
Photo 1 of 1 : UCIP_1057.jpg

LM Start	12.02	Rating **	M	Issue No.	43
LM End	12.02	Issue Type +	En	Location *	LS
Category	Supplemental			GPS Latitude/Longitude	
				Start	End
Item	DWR UCIP Field Study			39.626918 °	39.626918 °
				-122.001421 °	-122.001421 °
DWR ID	DWR_LD0001G_01_s_2014_43				
Action/Comments					
Inspector Comments: FS_ID:14569					
EP_NO: 9554					
Repair Type:					
Crossing Status:					
UCIP Comments: Flap gate heavily corroded. Good candidate for video inspection. Vegetation interfering with inlet.					
FIELD_STRUCT_DESC: 24-inch corrugated metal pipe through levee 7.0 feet below crown. Flap gate on waterward end. Slide gate in 36-inch corrugated metal pipe riser on waterward slope. Concrete headwalls on both ends. Two corrugated metal cutoff walls (ABO No. 9554, 1974). Originally included in the 1960 O&M manual.					
FS Date: 5/31/2013

Headwall and flapgate on WS toe.
